Site Visit Report

Date:	December 28, 2022	Prepared By:	Olivia Caton
Client:	Sutton Planning Board	Arrived on site:	12:00 PM
Project:	Unified Parkway Lots 2 and 3	Left site:	12:30 PM
Contractor:	Walsh Contracting Corp.	Site Conditions:	Dry
Contractor Contact:	John Walsh	Weather:	35°, Partly Cloudy

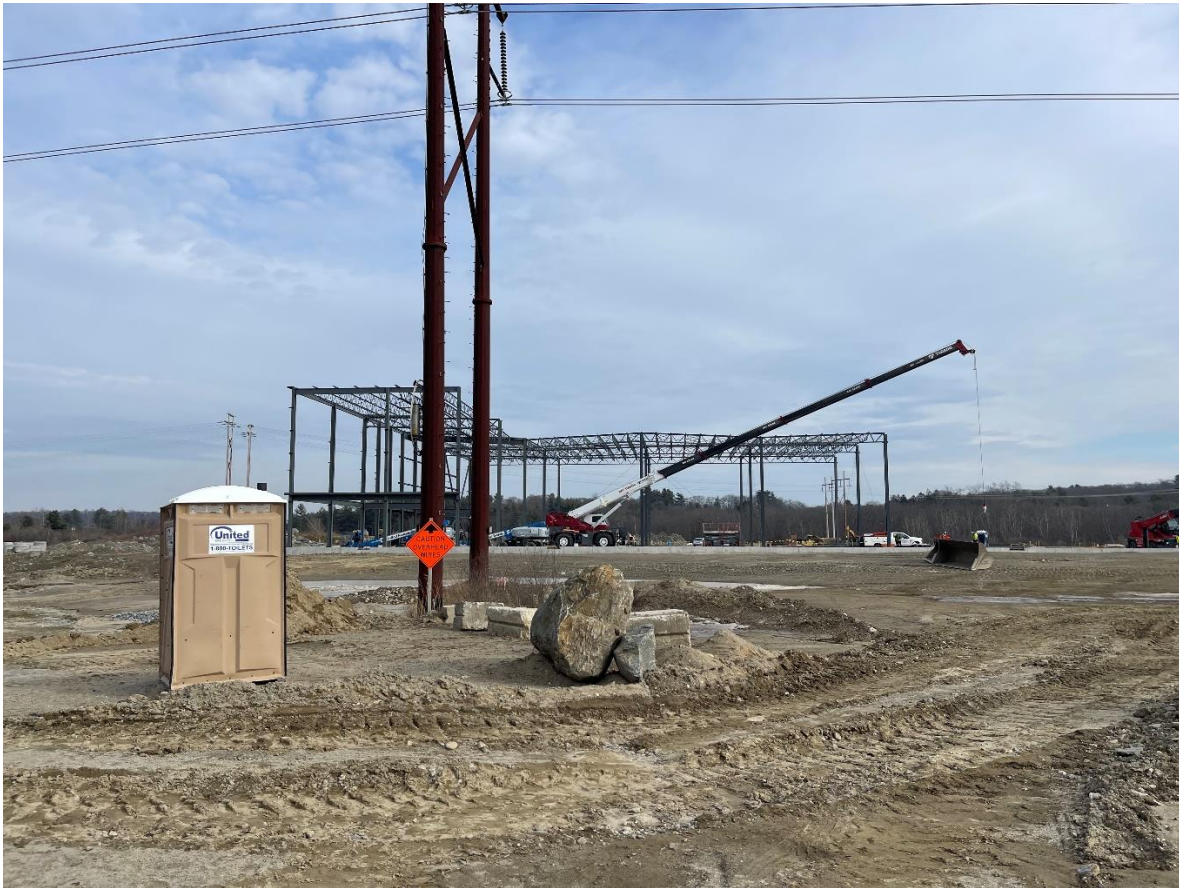
- The contractor continued installing the frame of Building 3.
- The contractor was excavating earth material between the locations of Drain Manhole (DMH) 603 and DMH 601.

Photo 1: The contractor continued installing the frame of Building 3.

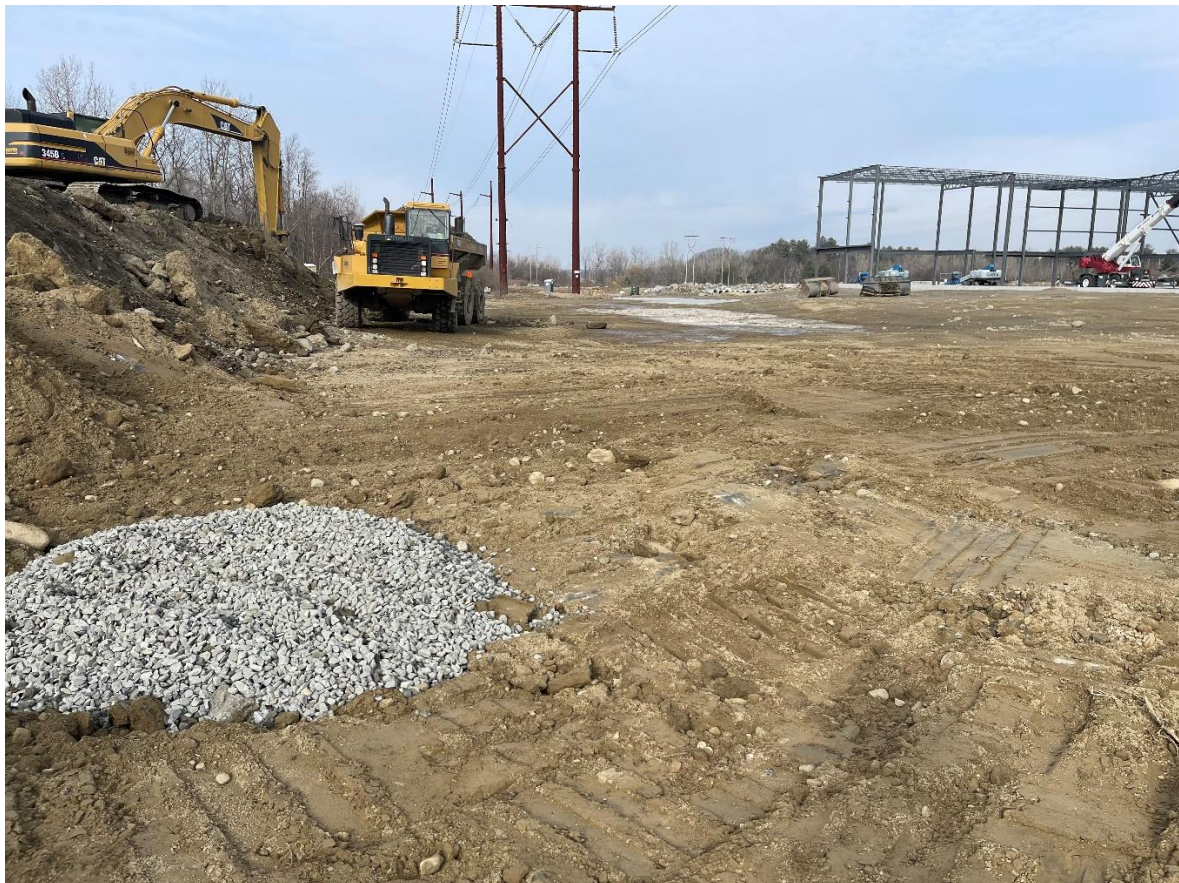
- MH 603 had been installed, backfilled, and covered in three-quarter-inch crushed stone.
- The following pipe had been installed and backfilled (Catch Basin = CB, reinforced concrete pipe = RCP):

From	To	Diameter (inches)	Length (feet)	Material
Previously Installed Pipe Past DMH 604	DMH 603	36	±130	RCP
DMH 701	CB 702	12	±30	RCP

Photo 2: The 36-inch RCP between DMH 604 and DMH 603 had been backfilled, and DMH 603 covered in three-quarter-inch crushed stone.
