### CMRPC – Recent Work

# Oxford & Sutton

**Sutton Avenue & Central Turnpike Corridor Profile**

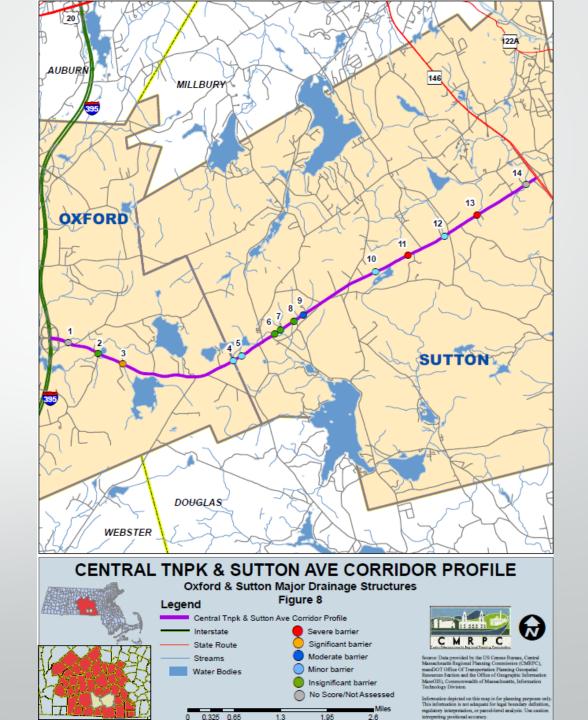
## Chapter 2: Environs

- Natural Environment
  - Impaired Waterways & Wellhead Protection Areas
  - Vernal Pools & Wetlands
  - Flood Zones
- Culverts

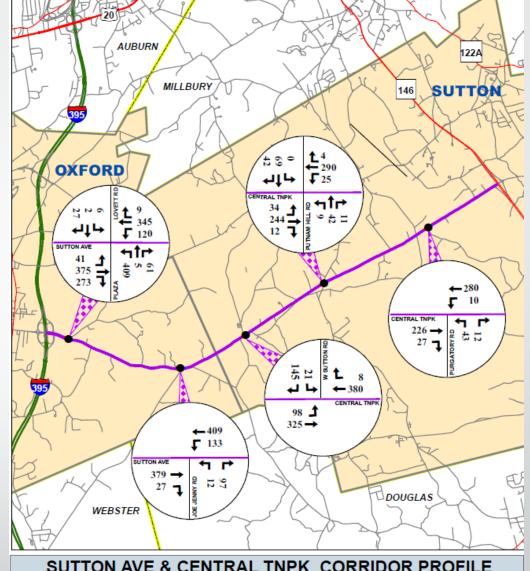
# Chapter 3: Congestion Management Process (CMP)

- Traffic Volumes (48-hour counts)
- Travel Time & Delay (7am-9am, 4pm-6m)
- Turning Movement Counts (TMCs) Existing & Projected (7am-9am, 4pm-6pm)
- Heavy Vehicle % at Focus Intersections
- Intersection Peak Hour Level of Service (LOS)

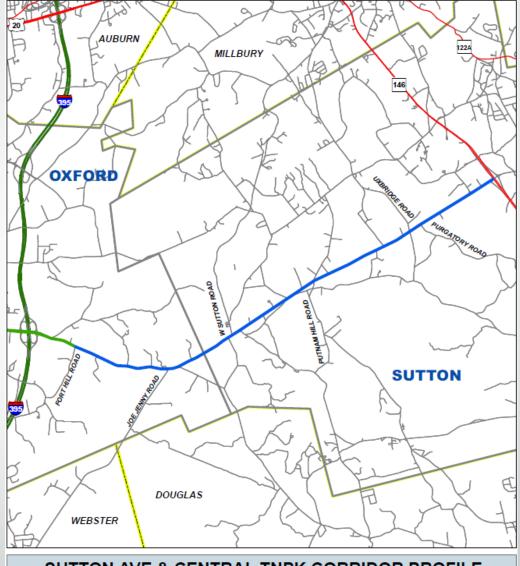
## **Chapter 5: Pavement**

Pavement Condition

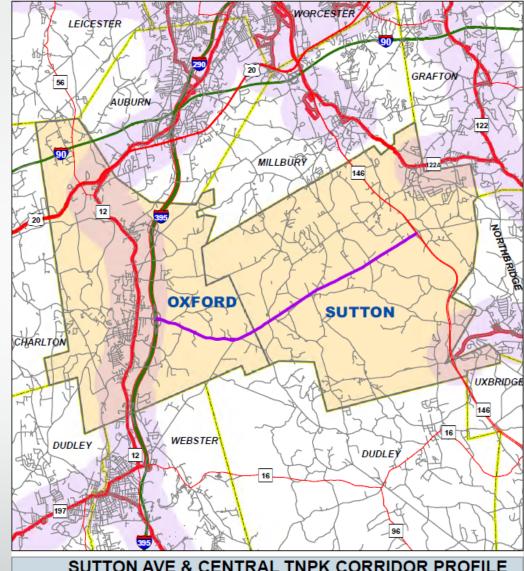
## Chapter 7: Public Transportation

- WRTA Bus Service
- Transportation
   Network Companies
   (TNCs) Rideshare Data

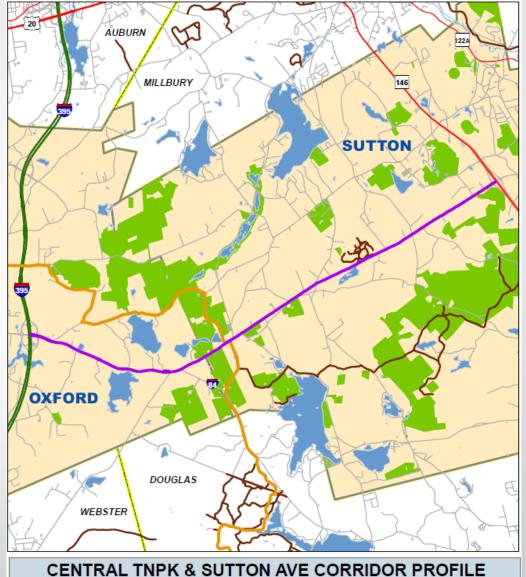
# Chapter 8: Other Modes

- Complete Streets
- Bicycling
- Pedestrians Facilities
- Trails
