--WOODBURY POND DAM--
PHASE I
INSPECTION / EVALUATION REPORT

Dam Name: Woodbury Pond Dam
NID ID#: MA01179
Owner: Town of Sutton
Town: Sutton, Massachusetts
Consultant: Weston & Sampson Engineers, Inc.
Date of Inspection: November 22, 2019

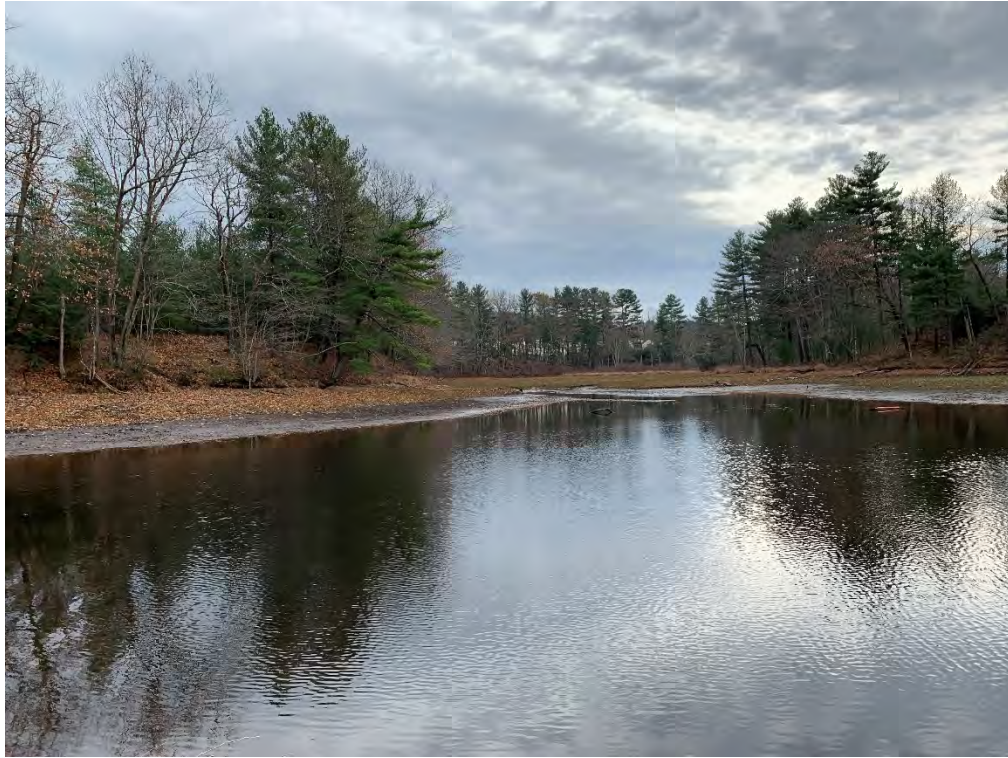
Based on observations from the dam crest, the reservoir shoreline is generally undeveloped and wooded with mild to moderate slopes and occasional apparent bedrock outcrops. Some residential properties are present along the southeastern shoreline. See **Photo 27**.

Photo 27 - Overview of the impoundment from the dam crest.
