# Prioritization Planning for Culvert Replacement

An Interactive Qualifying Project Proposal  
Submitted to the Faculty of  
WORCESTER POLYTECHNIC INSTITUTE  
In partial fulfillment of the requirements for the degree of Bachelor of Science.

Water Resource Outreach Center  
Massachusetts

Date:  
May 2, 2023

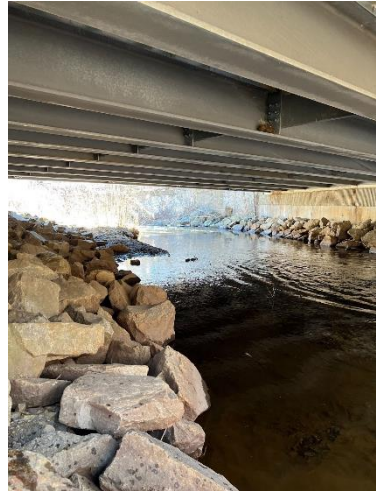
| Priority Code | Description | Example |
|---|---|---|
| 1 | Stream crossing and roadway have little to no structural defects or deterioration. The deficiencies that do exist are minor and could be addressed with isolated repair approaches; full crossing replacement is not warranted | |

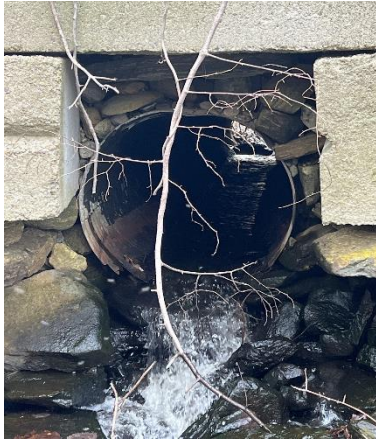
| Priority Code | Description | Example |
|---|---|---|
| 2 | Stream crossing and roadway have some minor and/or developing deficiencies that will likely need to be addressed soon. Full crossing and roadway replacement is likely the most appropriate way to address the deficiencies when the time comes to do so. | |

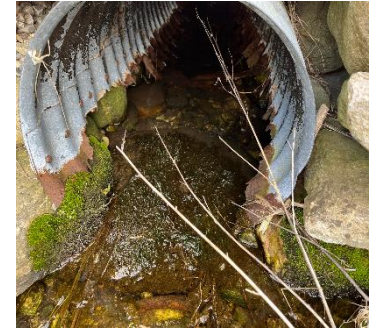
| Priority Code | Description | Example |
|---|---|---|
| 3 | Stream crossing and roadway have significant deficiencies that will likely need to be addressed soon as soon as funding is available. Full crossing and roadway replacement is needed to address the deficiencies. This could also include crossings for which the inlet or outlet are not able to be located/accessible. | |

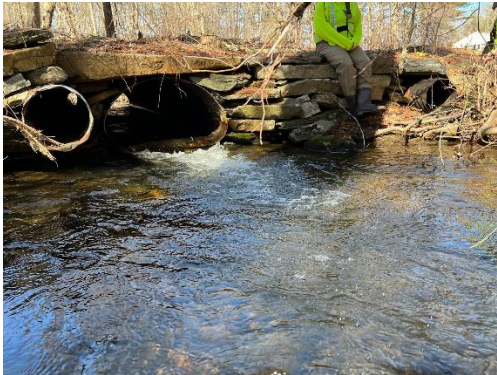
| Priority Code | Description | Example |
|---|---|---|
| 3 | Crossing is perched, blocked, or is significantly constrictive, making it not appropriately passable to aquatic or terrestrial organisms. | |

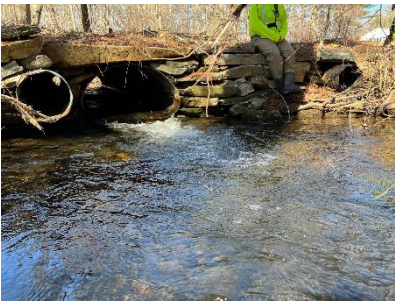
| Priority Code | Description | Example |
|---|---|---|
| 3 | Crossing span is less than 50% of the river's bankfull. Crossing height and overall geometry do not appear adequate and will likely impact water levels within the river during most rain events. There is a history of impacted water levels during most rain events. | |

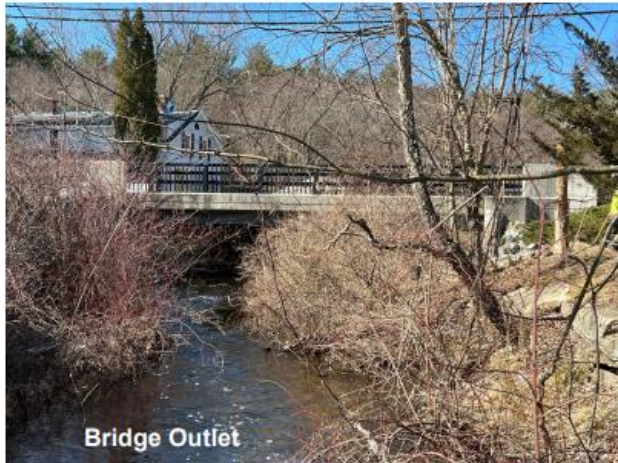
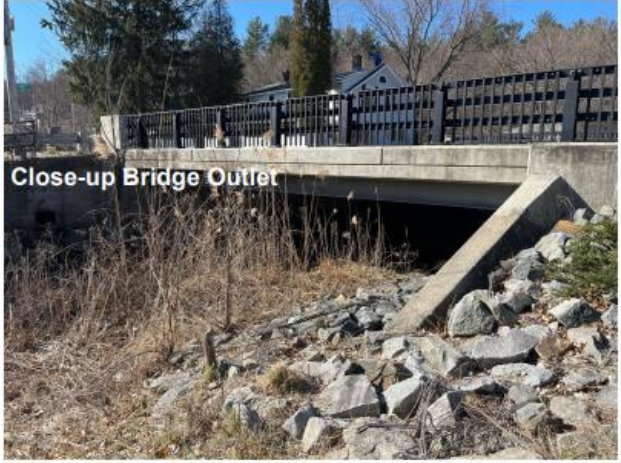
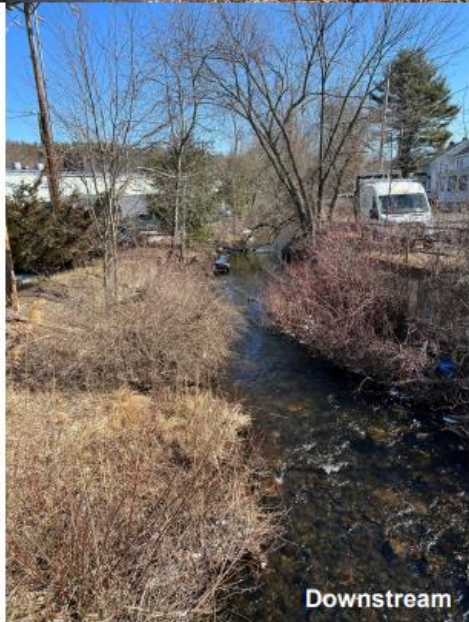
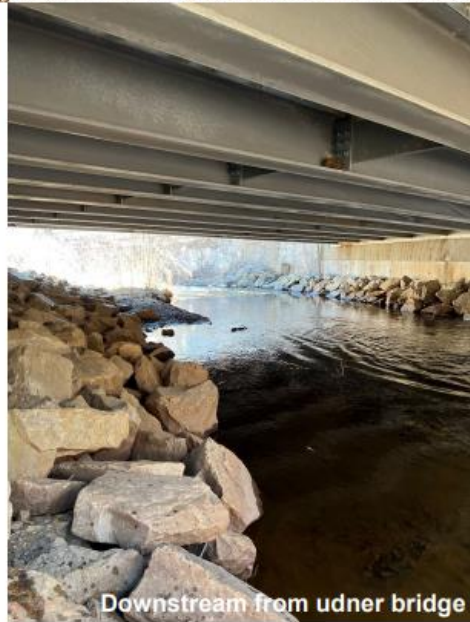
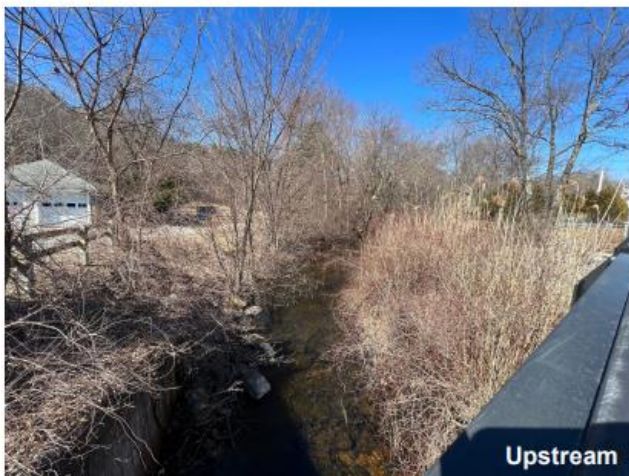
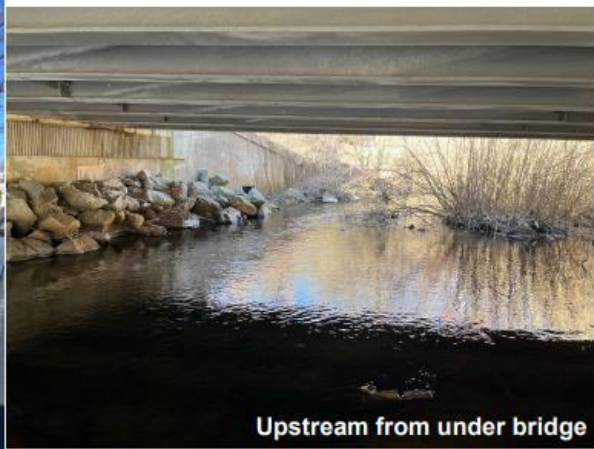
1 16' Bankfull 35.8 Bankfull up stream 40.0' average
