ROAD SAFETY AUDIT

Worcester - Providence Turnpike (Route 146)
at Boston Road
Town of Sutton
October 25, 2022

Prepared For:
MassDOT

Prepared By:
VHB
120 Front Street
Worcester, MA 01608

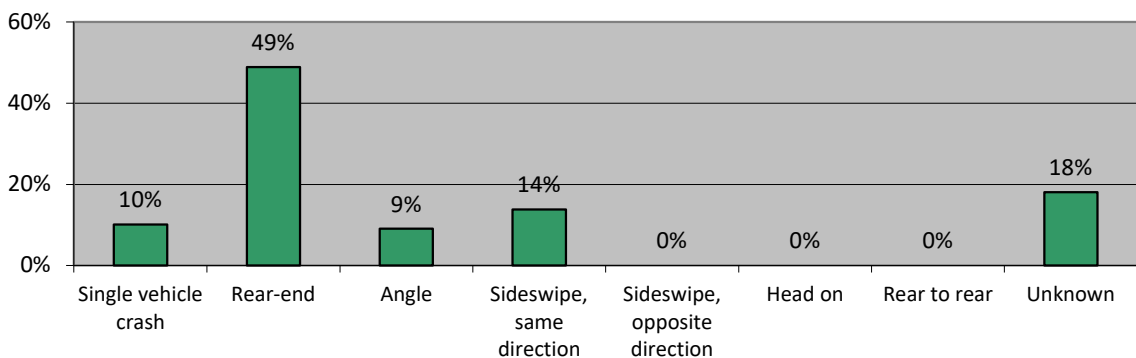
CRASH MANNER OF COLLISION

incidents to occur involved traffic travelling either northbound or southbound along Route 146. A total of 43 rear-end collisions occurred on Route 146 northbound and 35 occurred on Route 146 southbound. Sideswipe crashes also occurred most often along Route 146, with eleven sideswipes in the northbound direction and eight sideswipes observed in the southbound direction. Twenty-nine of the crashes along Route 146 resulted in injury, while only two of the crashes on Boston Road crashes did. Additionally, six crashes were caused by vehicles making illegal left turn movements from Route 146 northbound onto to Boston Road. No reported crashes involved pedestrians or bicyclists. Several crashes occurred at the various curb cuts near the intersection.

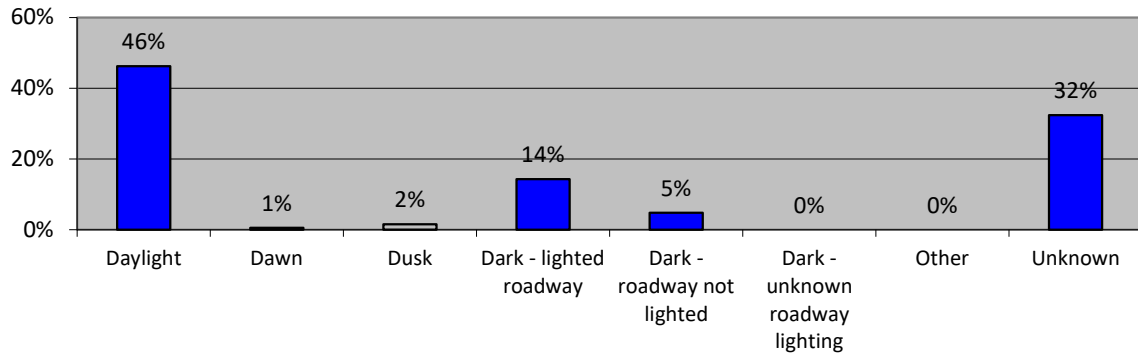
CRASH LIGHT CONDITION

Approximately 46 percent of crashes at the intersection occurred during daylight, 45 percent of crashes occurred during clear weather conditions and 48 percent of crashes occurred when the roadway surface was dry. A total of 19 percent of the crashes were reported as occurring in dark or nighttime conditions, with 14 percent reported as “dark – lighted roadway” conditions and 5 percent reported as “dark – roadway not lighted”. Additionally, twenty-two percent of crashes occurred on Fridays, and the time period with the most crashes was between 4 pm to 6 pm (16 percent). Heavy vehicles were involved with ten percent of the crashes that occurred at the intersection during the review period.
