## **HYDROGEOLOGIC ASSESSMENT**

### **SUTTON DOUGLAS DEVELOPMENT**

December 17, 2021

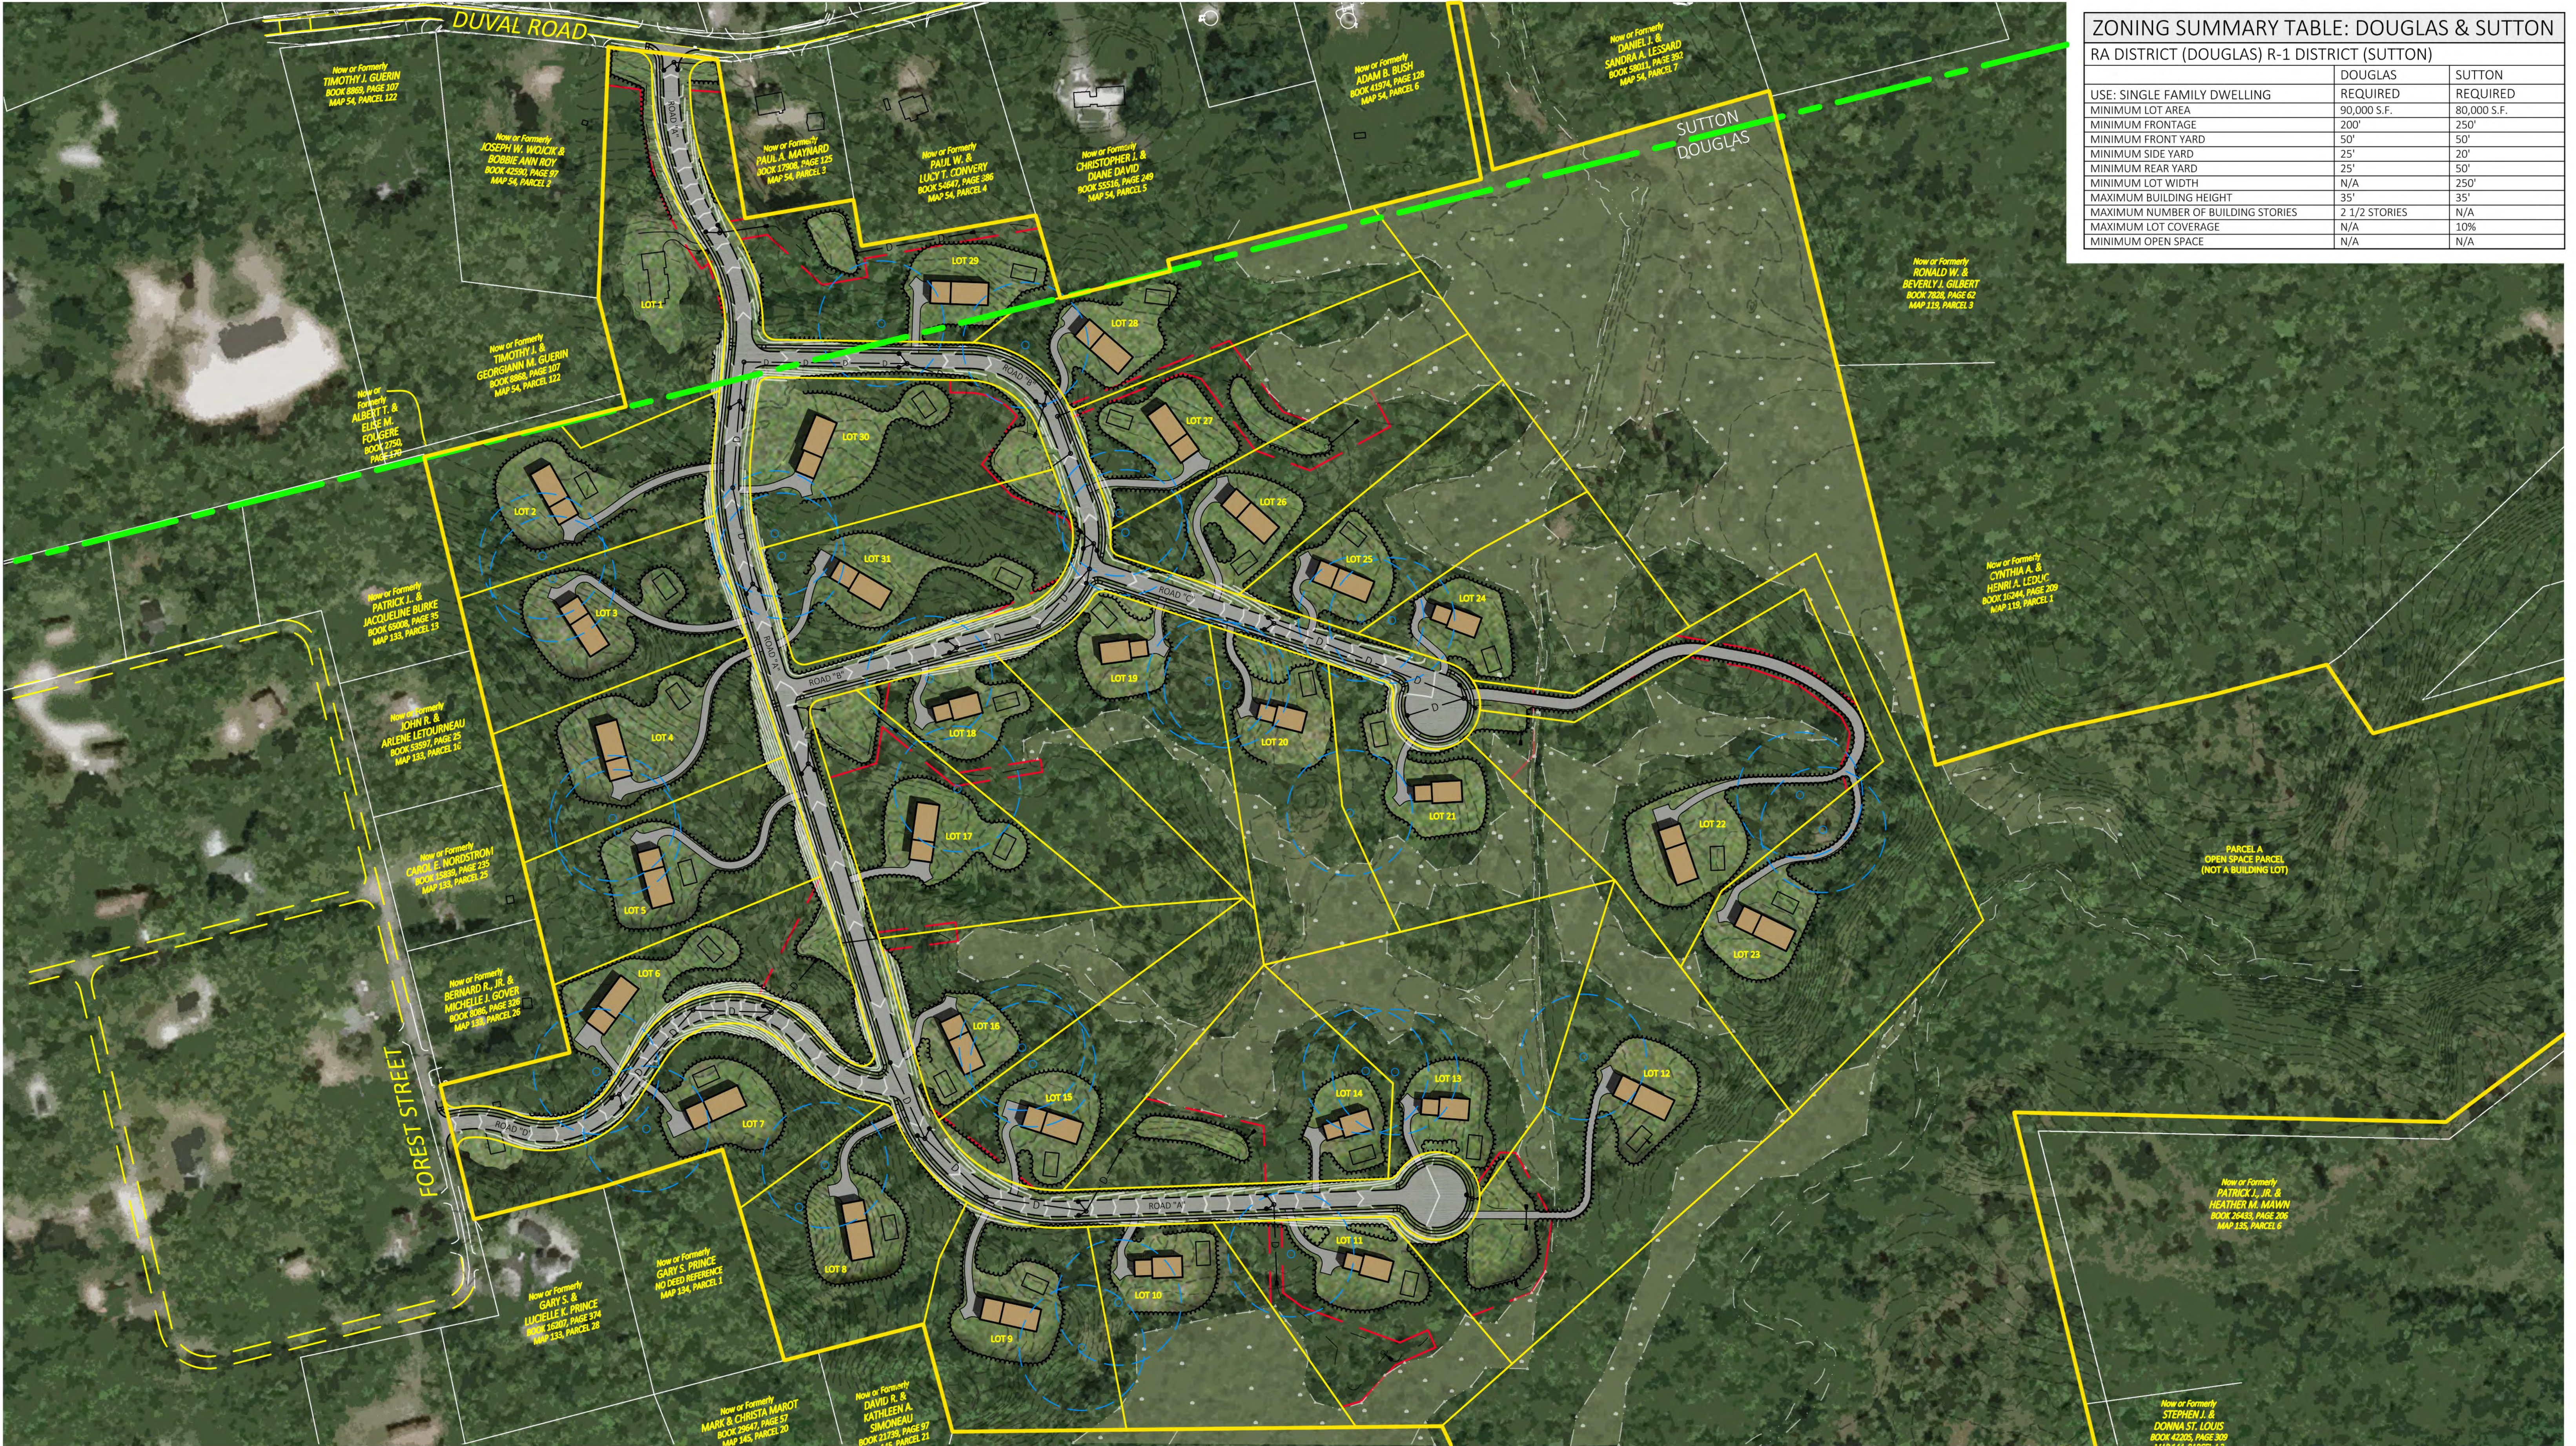
**ATTACHMENT A**  
**FIGURES DEPICTING PROPOSED SUTTON**  
**DOUGLAS DEVELOPMENT**
