Site Visit Report

Date: January 9, 2024
Client: Sutton Planning Board
Project: 15 Pleasant Valley Road
Contractor: Coastal Construction Corp.
Contractor Contact: Rian Kearney

Graves Engineering, Inc. (GEI) was on-site to observe excavation for the subsurface infiltration system. This site visit was conducted throughout the entire site. I met with Steve ____ of Anchor Excavating Corporation, Jack Guilford of Coastal Construction Corporation and Greg DiBona of Bohler. We observed the following:

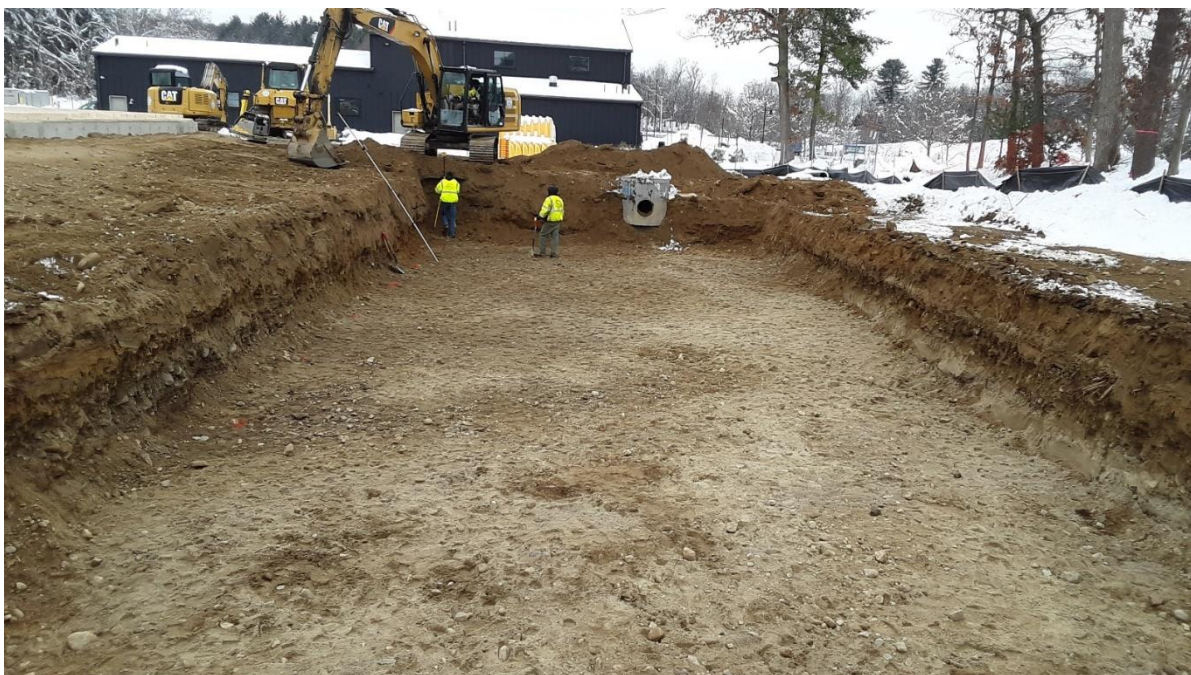
Photo 1: The bottom of the excavated area for the subsurface infiltration system had been scarified in a satisfactory manner.

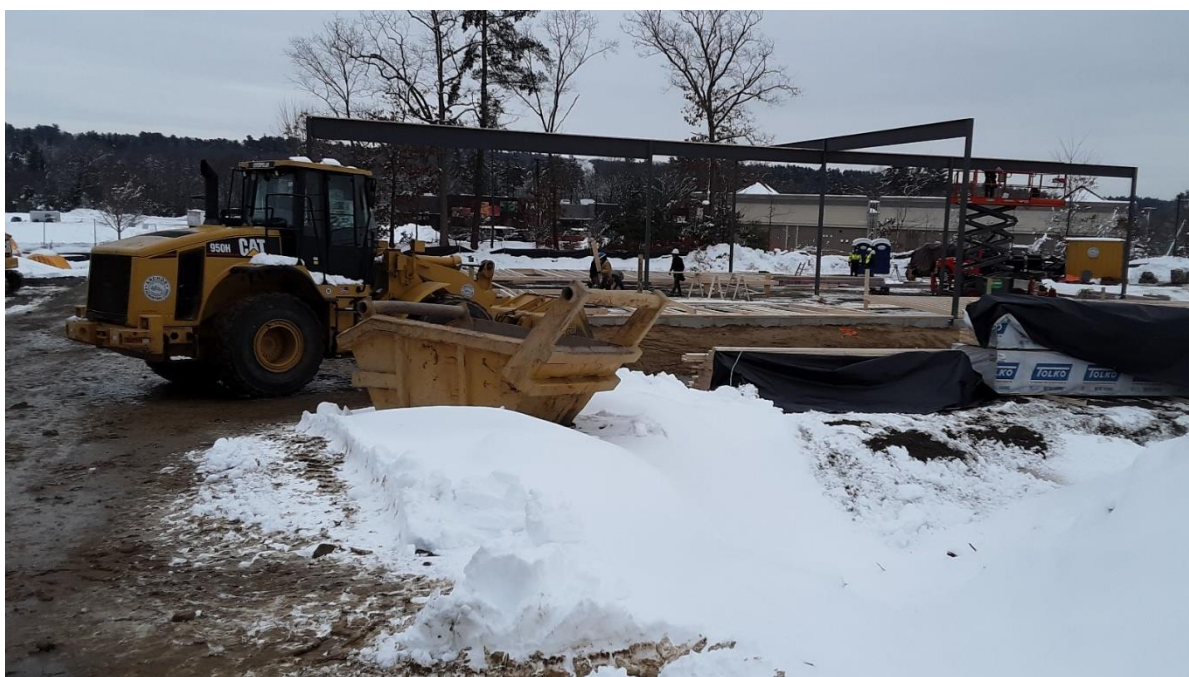
Photo 2: The contractor was installing the frame of the building.
