SITE INSPECTION MEMO

Re: Follow-Up Inspection – Blackstone Logistics Center – Lackey Dam Road & Route 146, Douglas,

Sutton & Uxbridge, MA (DEP File Nos. 303-0947, 312-1114, & 143-1017)

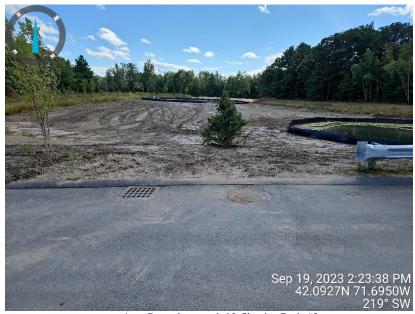
Upon entering the site I noted that a street sweeper was working to clean paved surfaces. I also noted that Infiltration Basin #2 had recently been re-graded and had been accessed from the site driveway. Regraded surfaces within the basin were largely unstabilized, except for new blankets on the northerly slope. I also noted that a large area, across the site driveway from Basin #2, had recently been re-graded and was unstabilized. Photos of these areas are attached. All disturbed surfaces should be stabilized immediately and confirmation of same should be provided. Going forward, please notify the Towns when this sort of work is going to commence and provide SWPPP reports, as required.

1. Recently re-graded Infiltration Basin #2

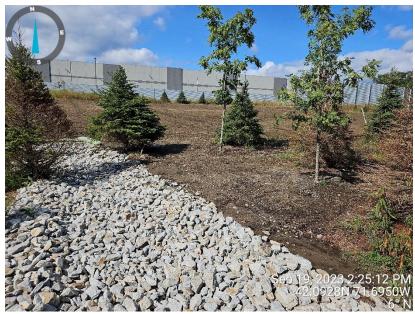
2. Recently re-graded area east of driveway entrance, south of building
